Project Completion Report

Policy Support for the Green Coast Project

Submitted to the World Wide Fund for Nature, India

August 2006

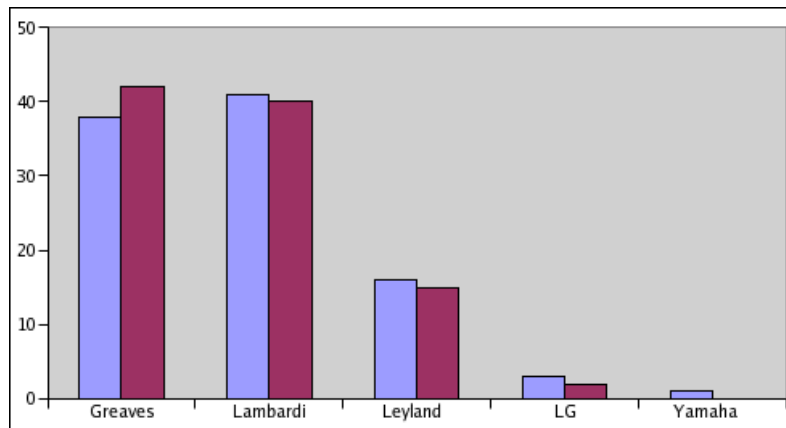
(a) Average numbers.

(b) Average power.

(c) Makes being used (blue=after, maroon=before the tsunami)

Figure 8.4.: Details of motors.

There has been a highly significant increase in the average number of motors being used in the hamlets ($t = -4.2335$, $df = 13$, $p\text{-value} = 0.0009767$). There is also a highly significant increase in the power of the motors ($t = -5.373$, $df = 8$, $p\text{-value} = 0.0006672$). The type of motors, shaft based versus “box type” did not change and remained at 16 and 83 respectively and there was a slight shift in the brands of motors being used (Figure 8.4).

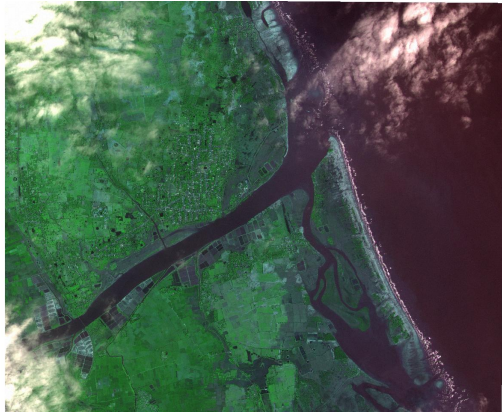
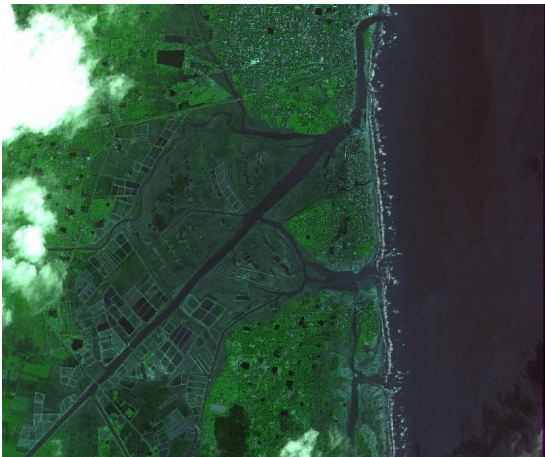
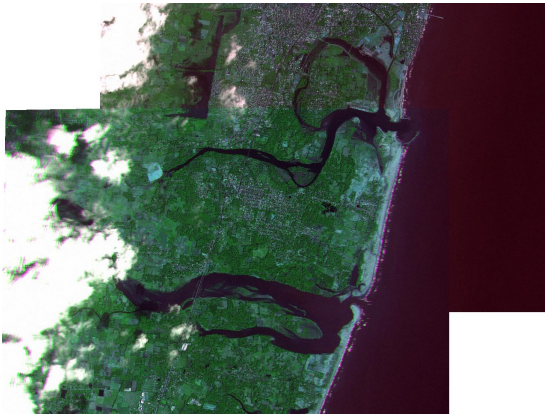
Figure 12.2.: Shrimp farms and salt pans occupy large areas around backwaters and river mouths along the Coramandel coast.

Shrimp farms along backwaters were a common violation in the more rural stretches of the Coramandel coast. Satellite imageries (figure 12.2) clearly show the extent of aquaculture ponds and salt pans.

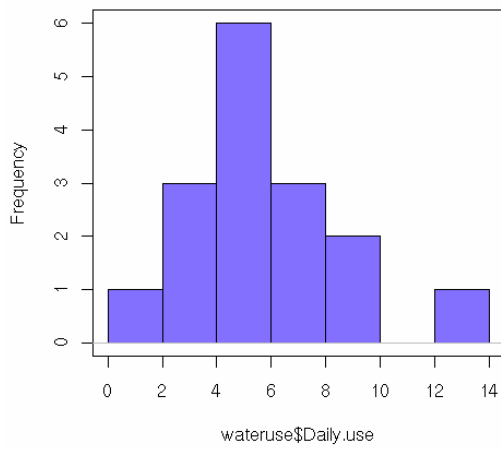
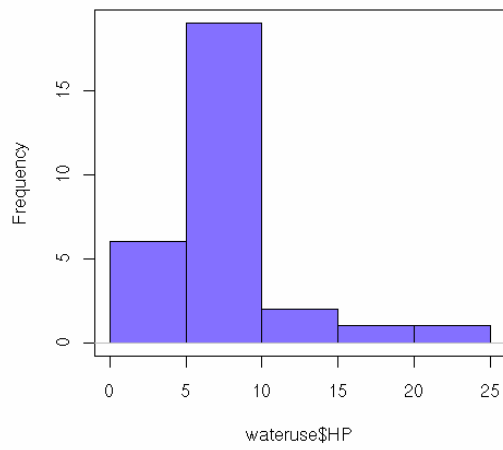
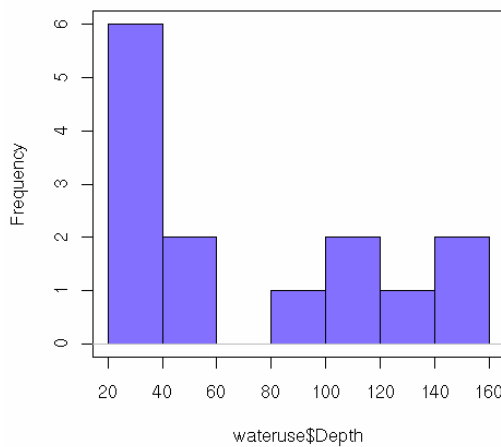
(a) Hours of pump use per day.

(b) Power of pumps being used.

(c) Depth of water source (for bore wells).

(d) Diameter of pipe.

Figure 12.4.: Details of water extraction for shrimp farming.

65% of the ponds depended on the backwater as their water, 27% on bore-wells and about 1% use both sources. While the number of samples did not permit a statistically valid analysis the data collected showed that backwaters had highest salinity and pH levels, the bore wells the lowest and the ponds between the two extremes (figure 12.5). Both diesel and electric pumps of varying power and pipe diameters were used as summarised in figure 12.4.

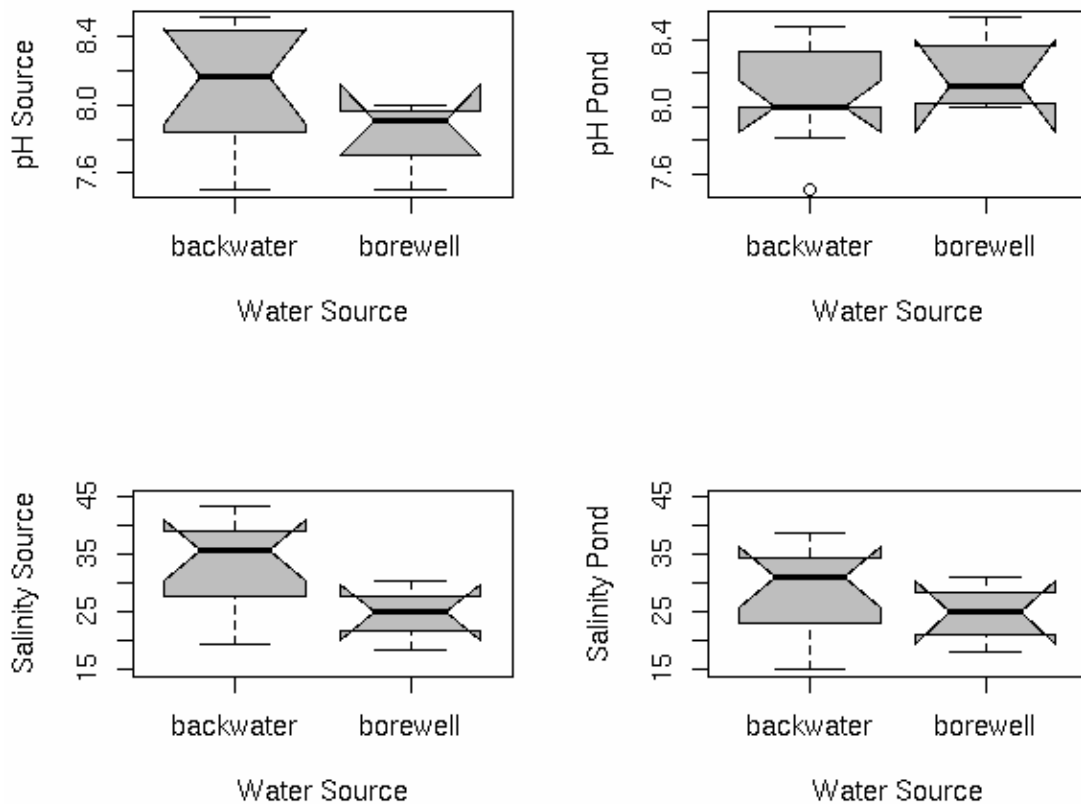
Figure 12.5.: Salinity and pH levels.

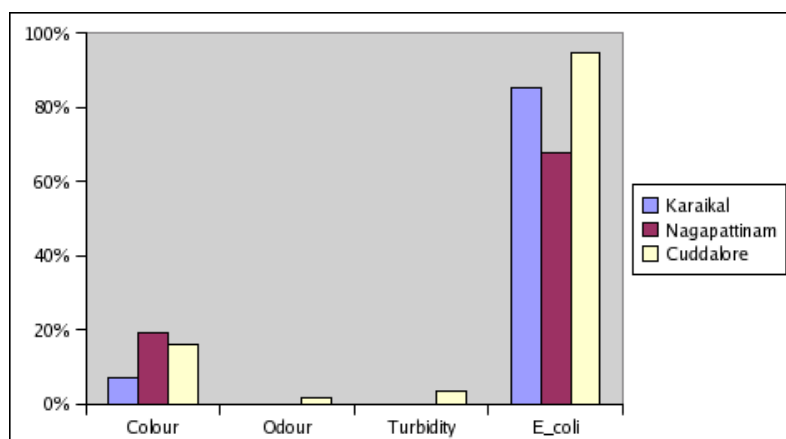
Figure 16.1.: Drinking water quality.

Figure 16.1 provides a summary of the status of water quality in the samples from the three

districts. Acceptable values for potable water under the Indian Standards Institute are presented in table 16.1. . The bulk of the samples had higher than permissible levels of e-coli. The average values for e-coli were 82.4, 72.3 and 231.5 for Karaikal, Nagapattinam and Cuddalore. Cuddalore had significantly higher levels of e-coli than either Nagapattinam or Karaikal as shown in figure 16.2.

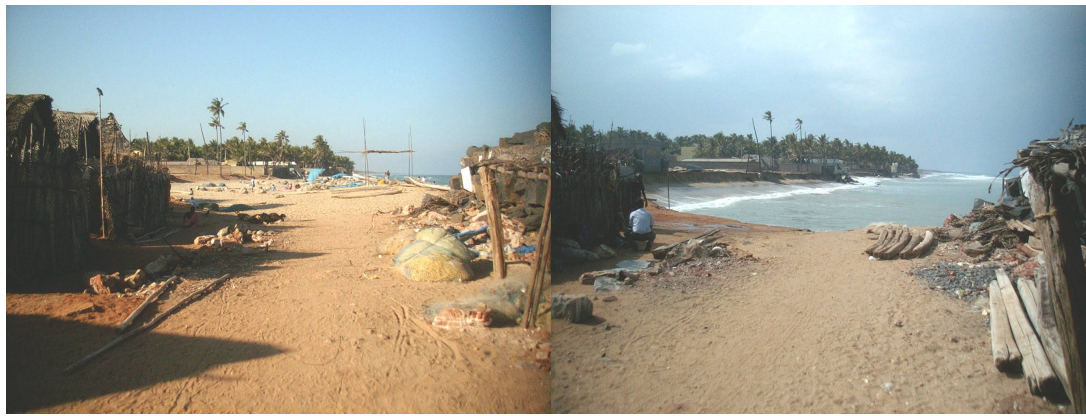
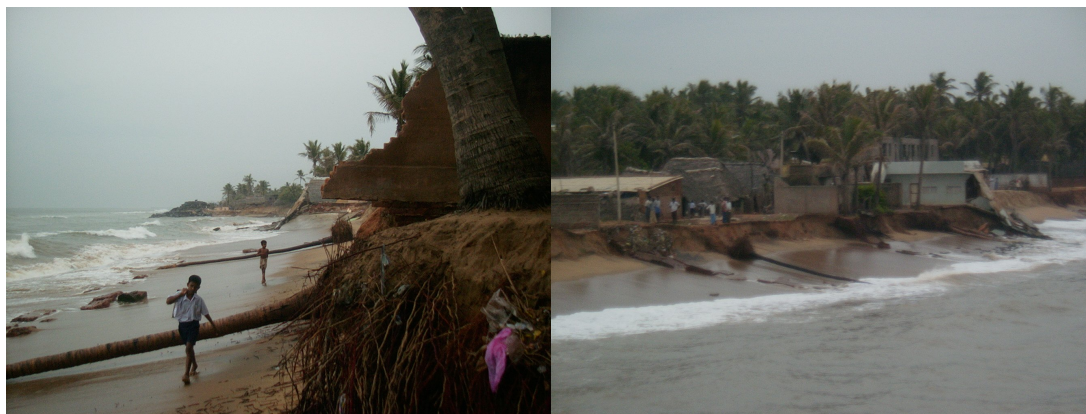
(a) Before

(b) After

Figure 18.1.: Loss of dwellings at Kotakuppam (photographs Aurofilio).

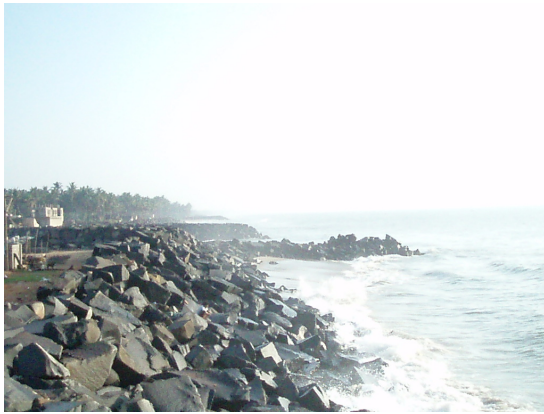
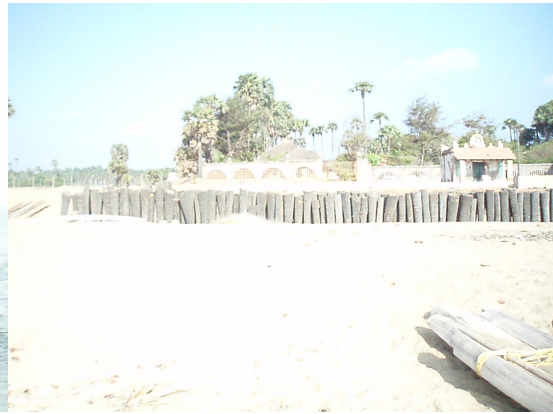
(a) Groynes at Kotakuppam.

(b) Stumps of palm trees, preparing for erosion at Chinnamudliarchavadi.

Figure 18.2.: Groynes at Kotakuppam and erosion further North.

In the case of Pondicherry there is clear evidence that the primary cause for erosion was the construction of the harbour at the mouth of Tengathittu estuary. With a net movement of sand towards the North (to the tune of 500,000 cubic metres), there has been a deposition of sand towards the South of the breakwater and a removal of sand to its North. This has resulted in the loss of the Pondicherry beach in a span of a decade since the breakwater was built. The erosion has moved further North into neighbouring Tamil Nadu. This resulted in the loss of dwellings on the coast (photographs 18.1) in a reaction to which Groynes and walls were constructed (photographs 18.2).

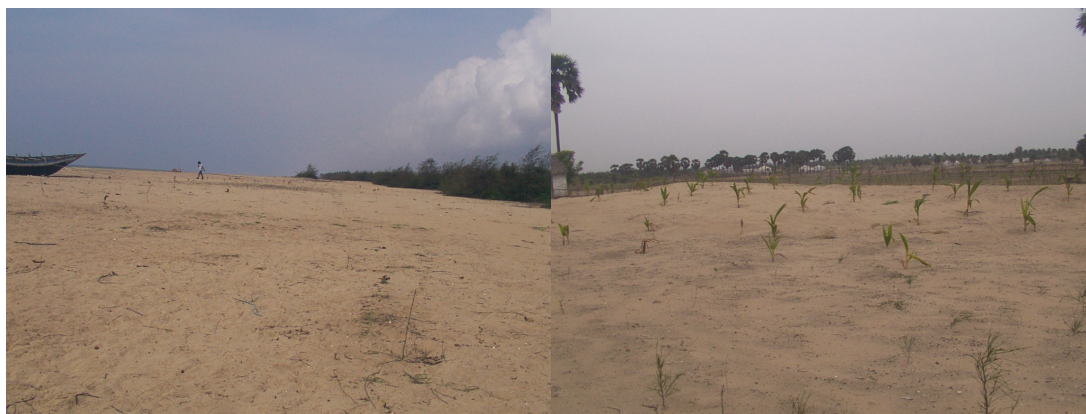
(a) A failed TDEF plantation.

(b) Coconuts planted on dunes in Pannithittu.

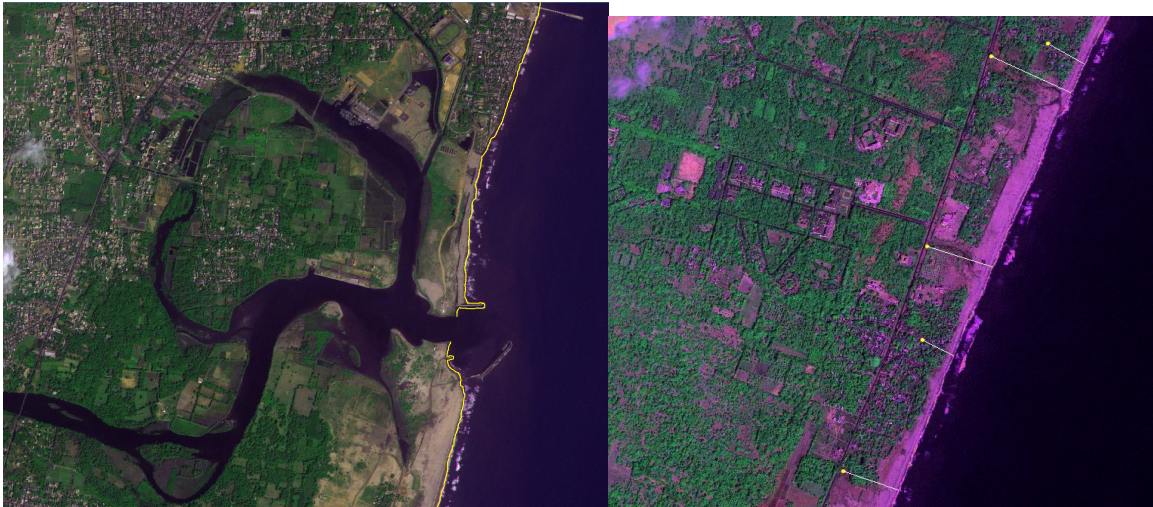
(a) RGB line

(b) The inundation line.

Figure 20.1.: The two baselines used.

The inundation of the tsunami was measured using a baseline corresponding to the coastline digitised from a high resolution image comprising of the red, green and blue band at 8 feet or 2.44 metres hybridised with a panchromatic band at 0.6 metres. This was done because water and moisture show up as negative values in an NDVI. This baseline thus provided the more conservative measurement of distance from the coast as wet areas affected by tidal action and soil moisture were treated as the coastline. River mouths and backwaters were digitised such that the coastline looped into them. Figure 20.1 illustrates this more clearly.

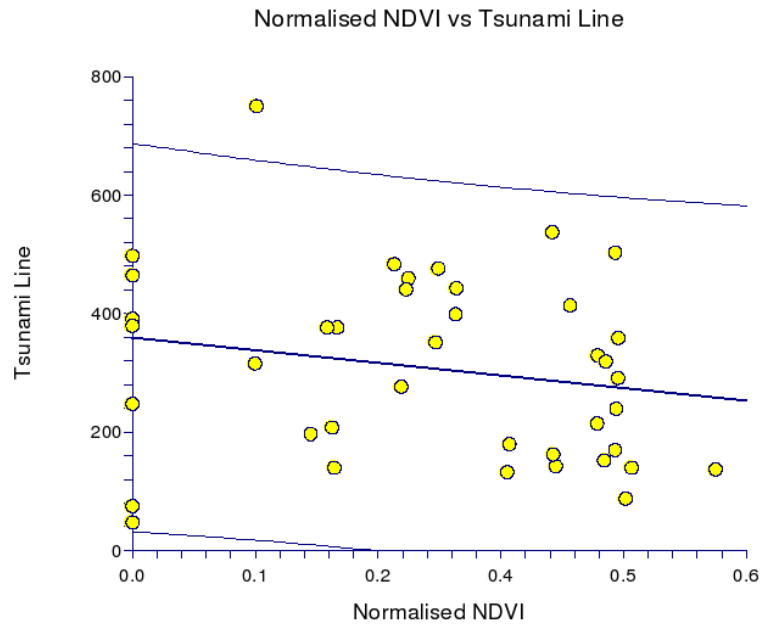
Figure 20.2.: The relationship between inundation and vegetation.
